# NON-TECHNICAL SUMMARY OF THE PANEL INVESTIGATION INTO THE WEST AFRICA COASTAL AREAS RESILIENCE INVESTMENT PROJECT (P162337), ADDITIONAL FINANCING (P176313) AND GLOBAL ENVIRONMENT FACILITY (GEF) (P092289)<sup>1</sup>

## The Project

The World Bank [WACA Project in Togo](#) (“WACA-Togo” or “the Project”)<sup>2</sup> is part of a regional [program](#), which includes 17 countries on the West Africa coast. Approved in April 2018, the Project aims to build resilience to address coastal erosion, enhance climate change adaptation, and foster sustainable development.

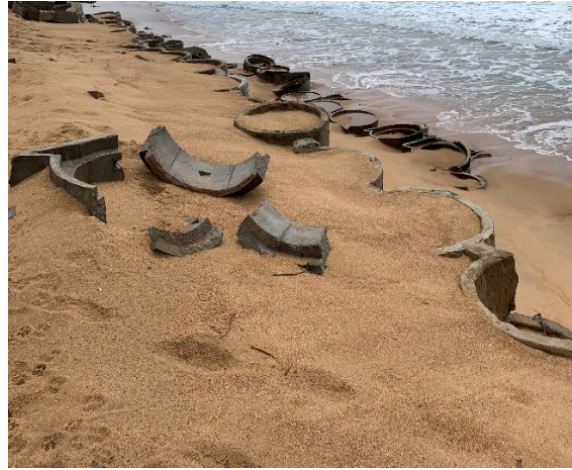
**The Emergency Works** – The Panel noted that the classification of the Emergency Works as Category C, meant that no environmental and social impact assessment would be conducted beyond the initial screening. As a result, the Project was unable to identify the impact of the construction of the concrete pipes, including on health and safety, or the impact of the continued presence of broken pipes on the community and their fishing equipment. Community members talked about the injuries they sustained during the construction of the pipes and as a result of the broken pipes scattered along the beach. Such injuries included a broken leg, the loss of a fingertip and chronic back pain, besides damaged boats, motors and fishnets.

**Environmental and Social Screening for the Emergency Works** – The Borrower hires a contractor to monitor pipe integrity, signage and lighting beacons, and manage the repair, removal, and clean-up of broken and dislocated pipe in the area of Emergency Works. It also hires community members to assist in the monitoring. Bank Management reviews the scope of works for this new contract and provide recommendations as may be needed, including a review of the terms of reference for the third-party monitors.

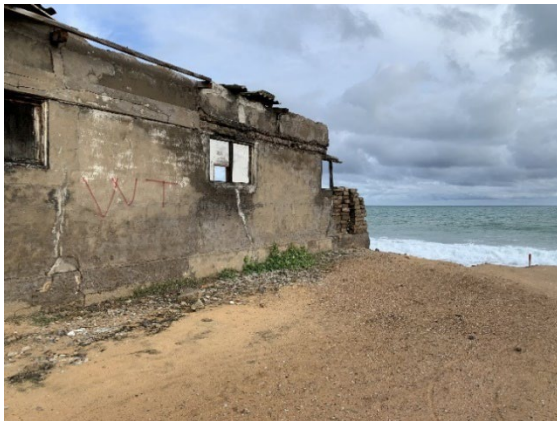
The Panel concluded that working conditions were hazardous and health and safety measures, such as the provision of personal protective equipment, were absent during construction of the pipes for the Emergency Works. Furthermore, no consideration was given to the decommissioning of the pipes despite the Emergency Works being a temporary solution.

**Construction of the Emergency Works and Working Conditions** – The Borrower advises communities that the GRM remains available to receive claims from those who allege suffering injuries or unpaid wages relating to the Emergency Works and that the claims need to be filed by the end of 2023. The Borrower reviews any unresolved claims and supporting documents for resolution. Bank Management reviews the outreach to the affected communities by Project closure to confirm the review and resolution of the claims.

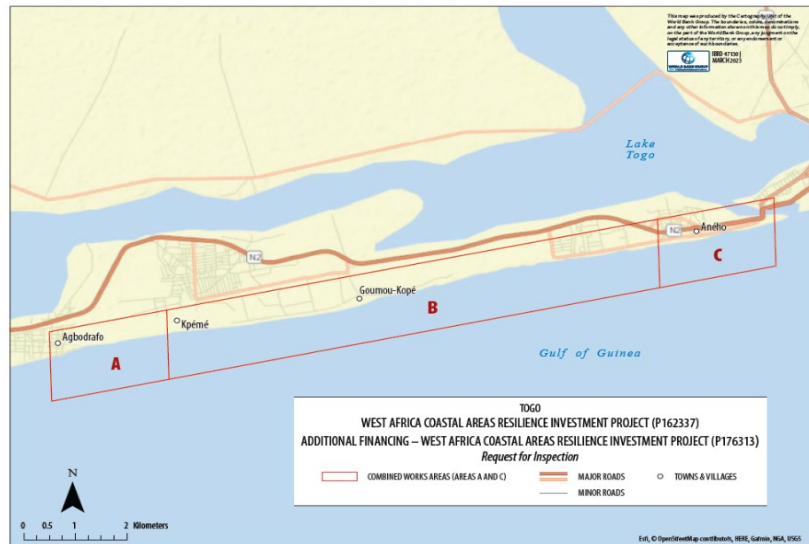
**The Combined Works** – The Project analyzed several alternative designs to build resilience to the ongoing coastal erosion. This analysis initially included the area from Kpémé to Aného (Area B below) which was subsequently excluded from the planned works.

The Panel's investigation found that the Project did not consider the impact of this exclusion. The Panel believes the groynes built west of Kpémé will curtail the eastward flow of sediment and therefore may cause increased erosion and flooding in Area B (Kpémé to Aného) as compared with the current rate of erosion and the number of flood events in this area is also likely to increase.

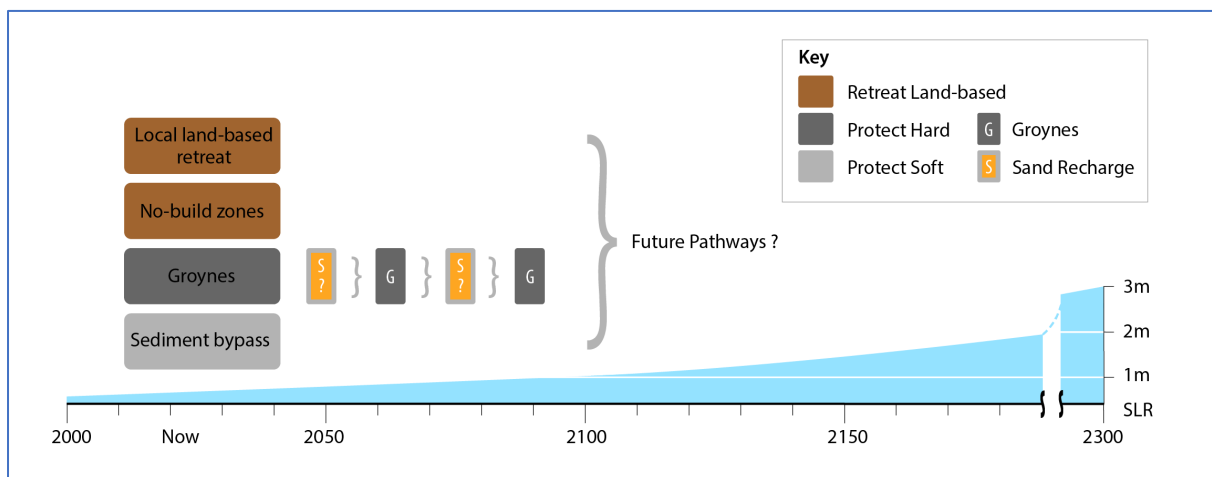
A technical annex to the investigation report explains the concept of ‘adaptation pathway’, which can be highly useful in the preparation of similar projects.

Due to the impact of climate change to low lying coastal areas, Togo will need to adapt to the long-term increase of sea-level rise and storminess. The expectation is that the coast of Togo will likely witness an increase of sea-level rise of a rate of an approximate one meter per hundred years. Long-term adaptation and resilience measures will likely be needed and could include a combination of soft measures mimicking or supporting natural processes (such as adding vegetation and sand, to mitigate deficits in sediment supply, or restoring wetlands and mangrove forests), and the construction of hard measures (such as groynes, breakwaters, seawalls, and dykes) to resist erosion or flooding by waves and storms. Simultaneously, it requires developing and implementing appropriate policies to adapt to the continued effects of climate change.
